IX CONGRESSO BRASILEIRO DE PONTES E ESTRUTURAS  
18 a 20 de maio, 2016 - Everest Rio Hotel

## **Damage assessment for the structural rehabilitation of a trussed bridge on Ferrovia do Aço Railway.**

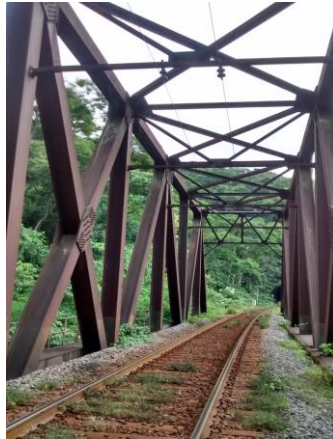
**Figure 1 - Truss bridge over the Fumaça Waterfall**

Fumaça Waterfall bridge is a 70m span truss bridge. Two planar steel Pratt trusses, 12m in height, separated from each other by a distance of 6.2m, assemble the main structure. Trusses are composed by I sections connected with black bolts. (Figure 1) The deck is of open grillage that supports reinforced concrete boxes where railway tracks are rested. Two longitudinal joists (I section) and ten transverse joists (I section) compose the grillage, i.e. the structure

that supports the concrete boxes. Connection between longitudinal and transversal joists is done with angle sections, welded to the web of longitudinal joists and bolted to the web of transversal joists. Connection between longitudinal and transversal joists to concrete deck is done with shear connectors (studs).

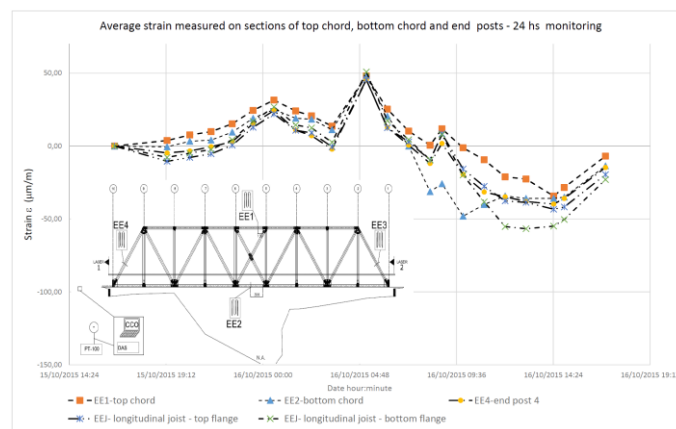
**Figure 9 - Temporal series of strain measured on sections of top chord, bottom chord, end post and longitudinal joist.**

To evaluate thermal effects on bridge structure, a 24 hours continuous monitoring was accomplished. During monitoring, temperature variation was 12.6°C, with minimum of 21.7°C and maximum of 34.3°C. Temporal series of strain are presented on Figure 9. In this case, mean of strains were calculated hourly, in the break when there were not train on rail.

Maxima strain variation due to temperature variation were 130.4µm/m and 235.0µm/m respectively on top and bottom chord, 152.8µm/m and 151.9µm/m on end posts and 121.5µm/m on the flanges of longitudinal joist.
